DE RUYTER DAM
ONONDAGA COUNTY
NEW YORK

INVENTORY NO NY 774

PHASE I INSPECTION REPORT
NATIONAL DAM SAFETY PROGRAM

JULY 1979

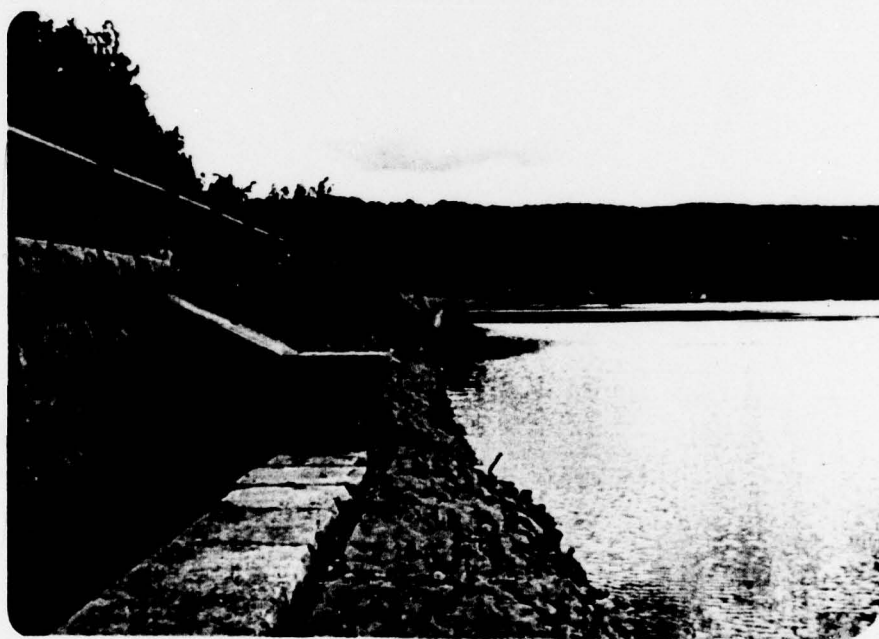
Overview of DeRuyter earth embankment dam located in Southeast Onondaga County, New York.

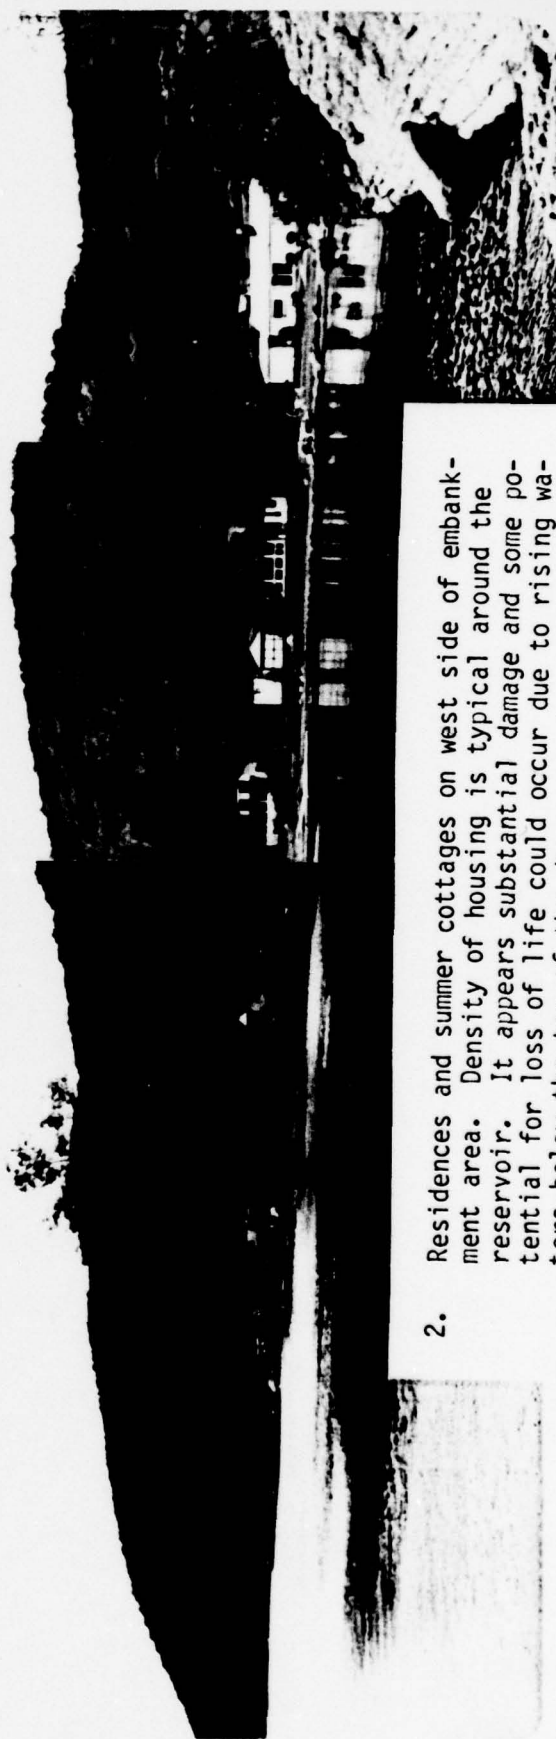
2. Residences and summer cottages on west side of embankment area. Density of housing is typical around the reservoir. It appears substantial damage and some potential for loss of life could occur due to rising waters below the top of the dam.

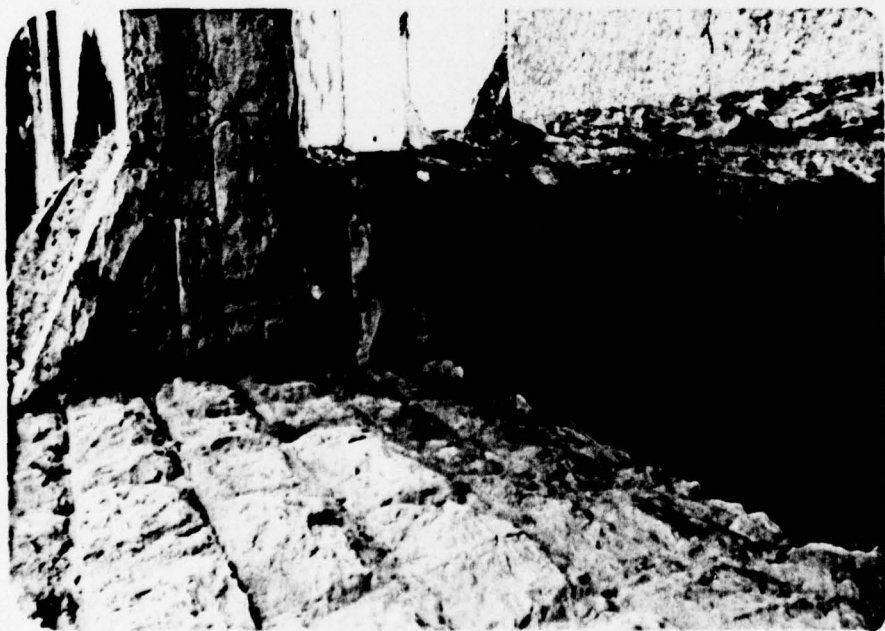
3. Masonry spillway weir. Some separation of stone masonry.

The main spillway located near the west abutment of the dam is in generally good condition. There is some deterioration in the masonry joints, but this is of minor concern. The arch culvert, which receives the flow from the spillway, is in good condition as is the masonry channel downstream from the culvert. The extreme northerly end of the masonry channel is severely deteriorated and undermined. This deterioration will progress up the channel if repairs are not made.

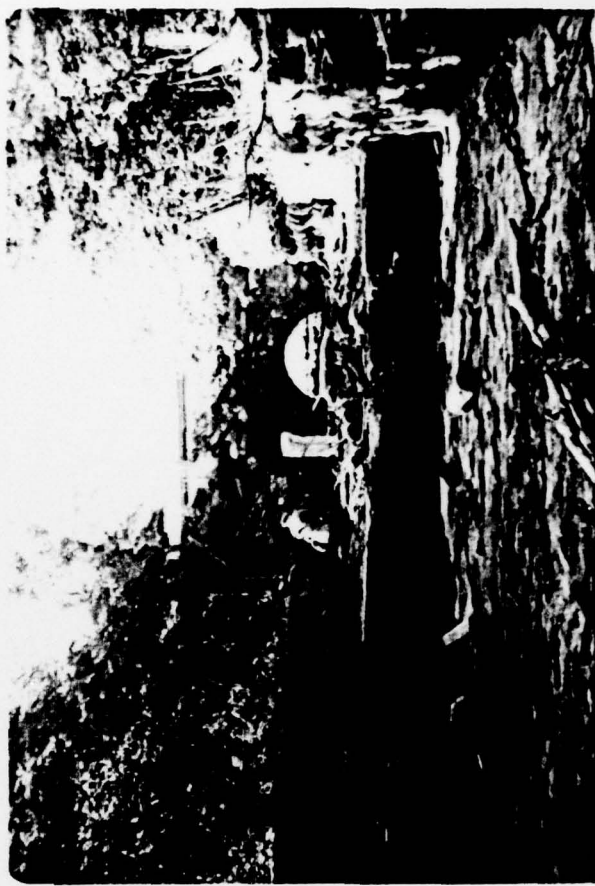
Rising waters flooding residences around the lake could pick up floatable debris which would clog the stone arch spillway culvert structure causing the dam to be overtopped. Complete clogging of the high level spillway could cause the dam to be overtopped by 2-3 feet.

4. Upstream and downstream view of spillway culvert below road across top of dam.

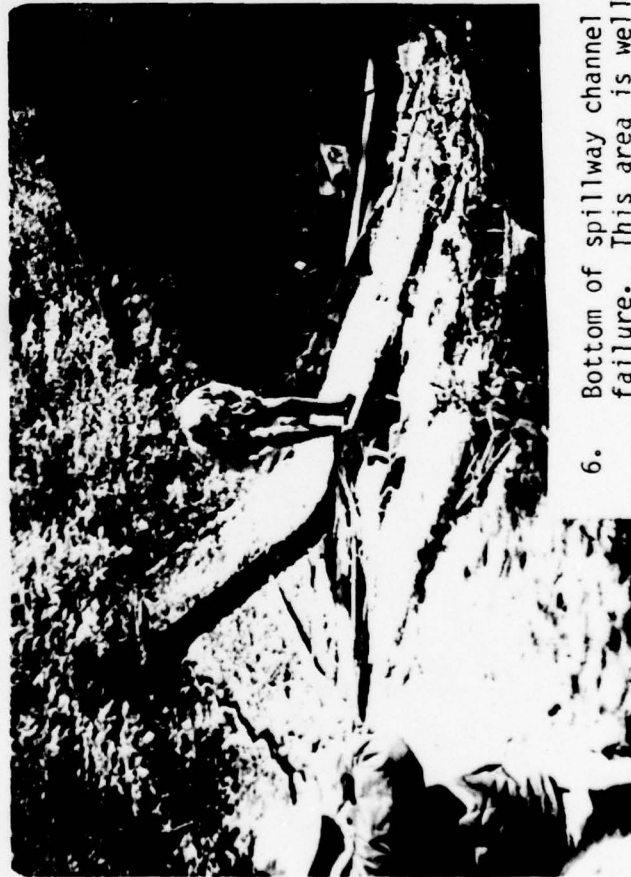
6. Bottom of spillway channel displaced due to foundation failure. This area is well below dam. See plans enclosed in report.

7. The extreme northerly end of the masonry spillway channel is severely deteriorated and undermined. This deterioration will progress up the channel if repairs are not made.

7. The spillway and outlet channel should be repaired to prevent progressive damage. Damaged and deteriorated areas of the outlet channel should be rehabilitated. A maintenance program should include periodic removal of heavy debris from the channel.

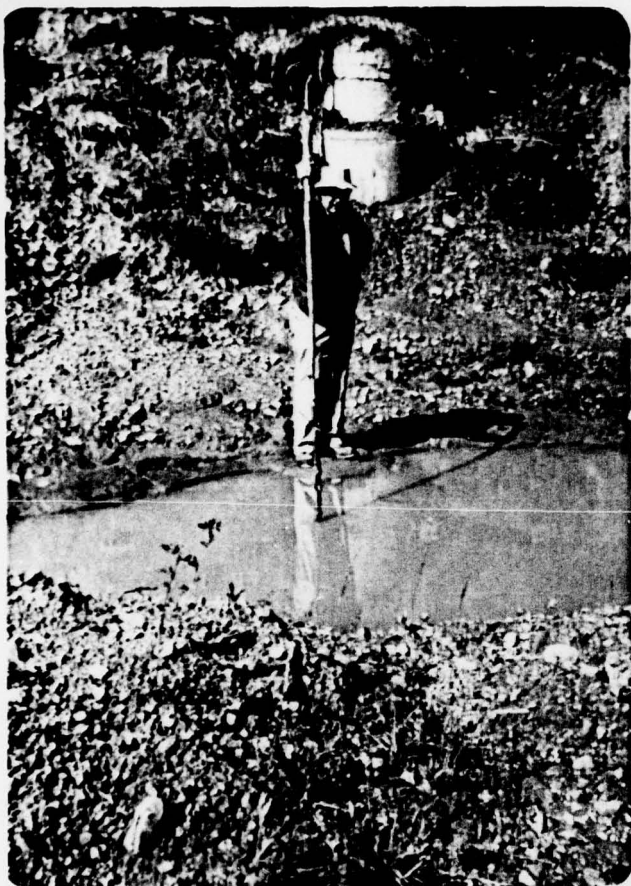
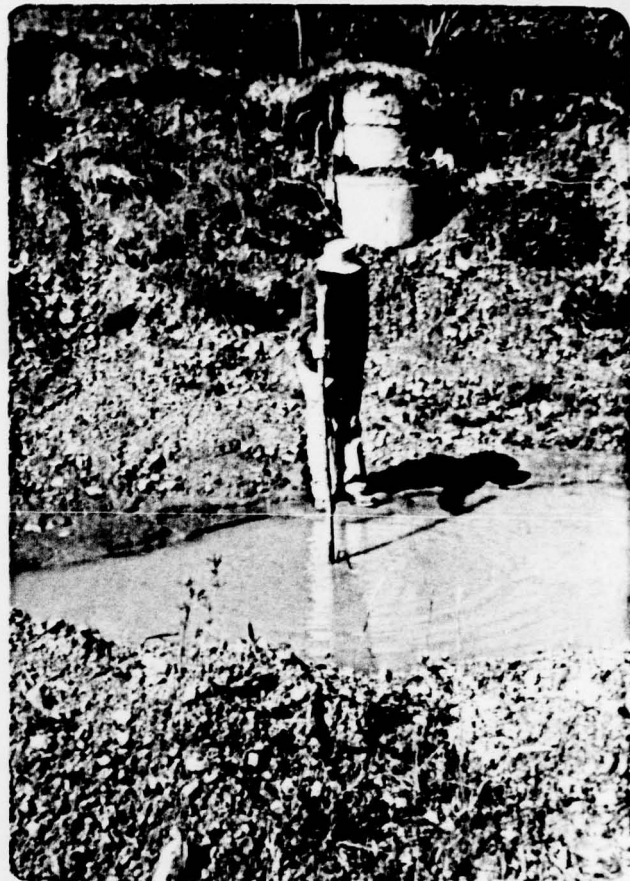
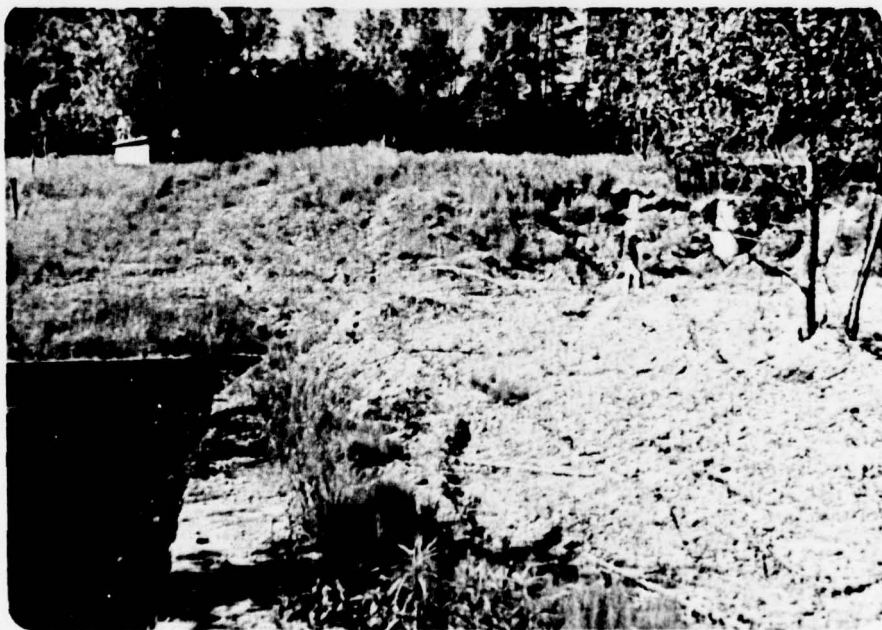
7. Area in deep section of embankment where drainage system was repaired and needs to be regraded.

4. An excavation and repair on the subdrain system near the center of the embankment performed in 1978 to repair blockage in the drain line has not been backfilled.

2. Backfill the open excavation at the toe of the dam near the center of the embankment.
3. Brush on the downstream side should be removed to permit easier access to all areas and permit better observation/detection of seeping areas or other conditions requiring attention. Trees on the embankment should be removed to eliminate damage from storm-caused uprooting.

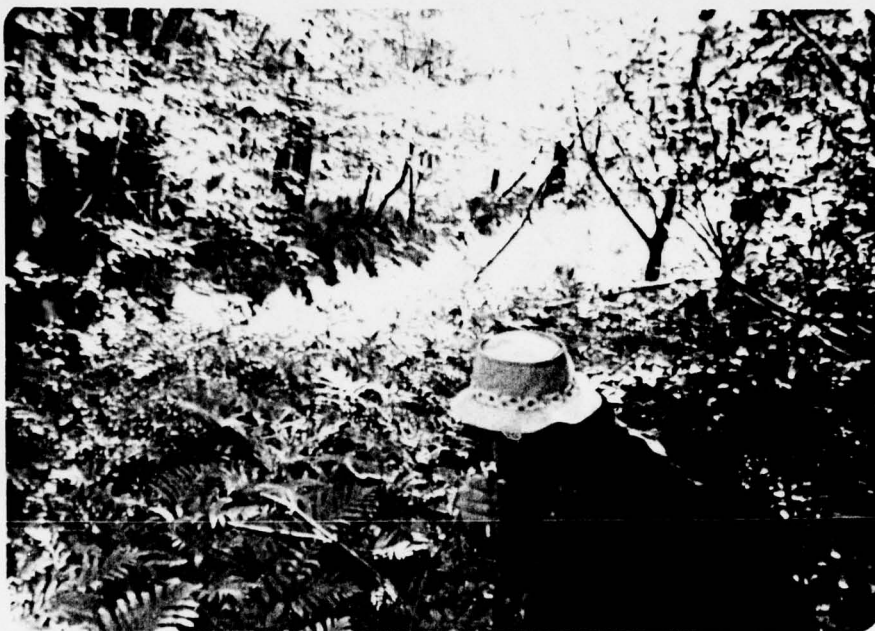
8. Wet area along drainage ditch at toe of embankment on west portion of dam.

3. A seepage condition is present throughout the general vicinity of the dams central downstream embankment area near the toe. Saturated and soft soils and marsh vegetation exist in this area even though the dam has an extensive underdrain system.

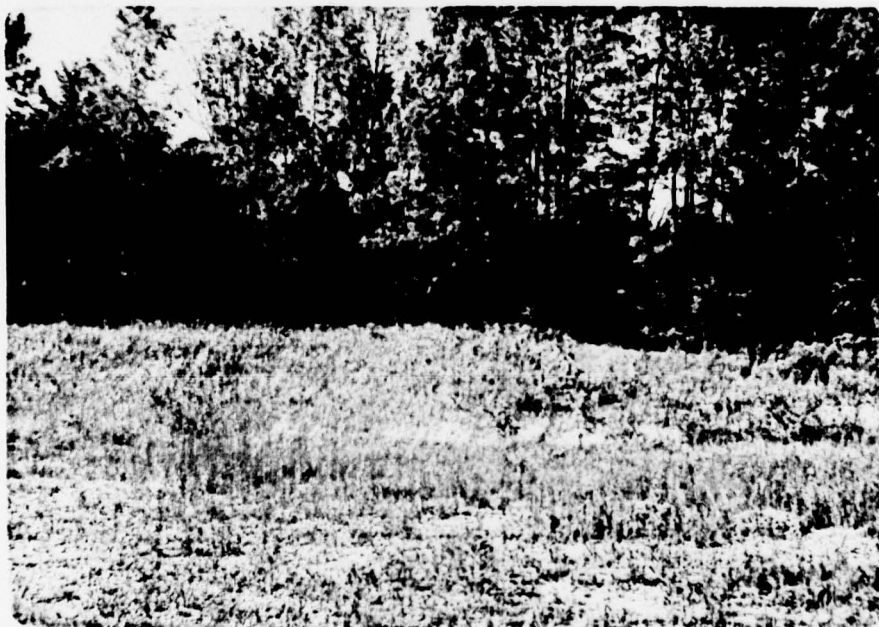
9. View of trees growing near top of embankment. At deepest section, embankment is very wide.

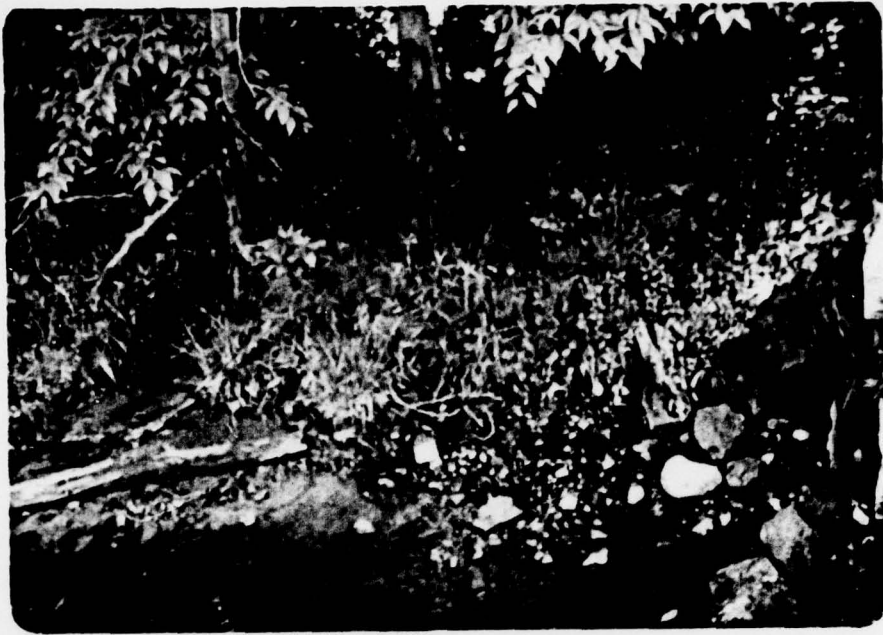
10. Drain outlet for east side of dam where it discharges into main channel.

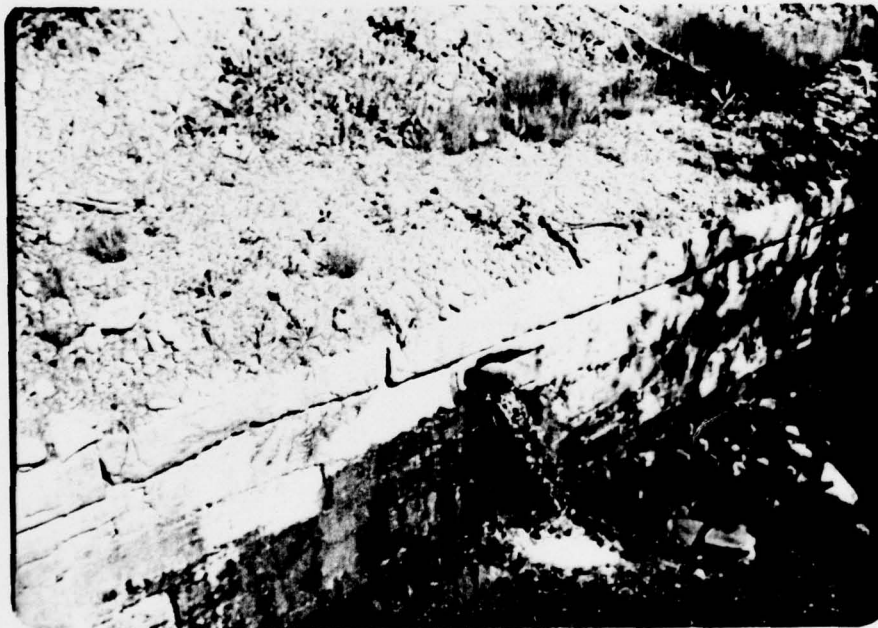
11. Substantial flow from west side of dam drainage system.

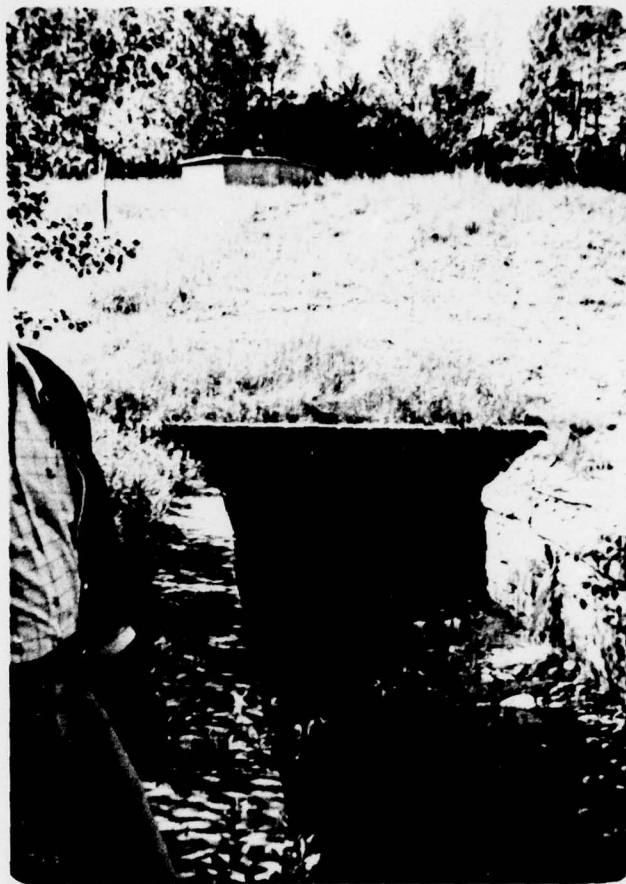
12. Regulated outflow below dam controlled from gates contained in silo seen above.
